Movement of Tagged Dredged Sand at Thalweg Disposal Sites in the Upper Mississippi River

Volume 3:
Additional Results at Gordon's Ferry
and Whitney Island Sites

ANL/EES-TM-270, Vol. 3

April 1985

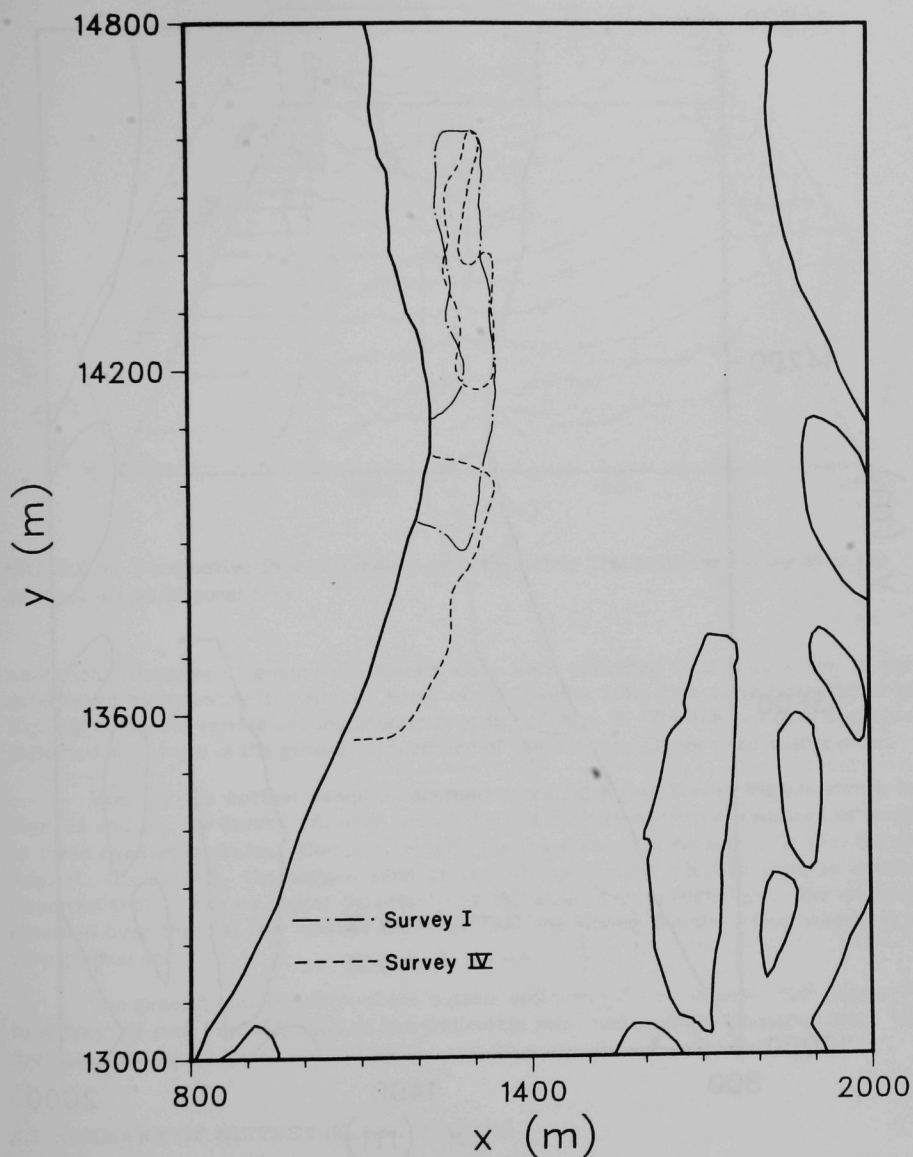
FIGURE 48 Distribution of Tagged Sand after Disposal and after the December 1982 Flood at the Whitney Island Disposal Site

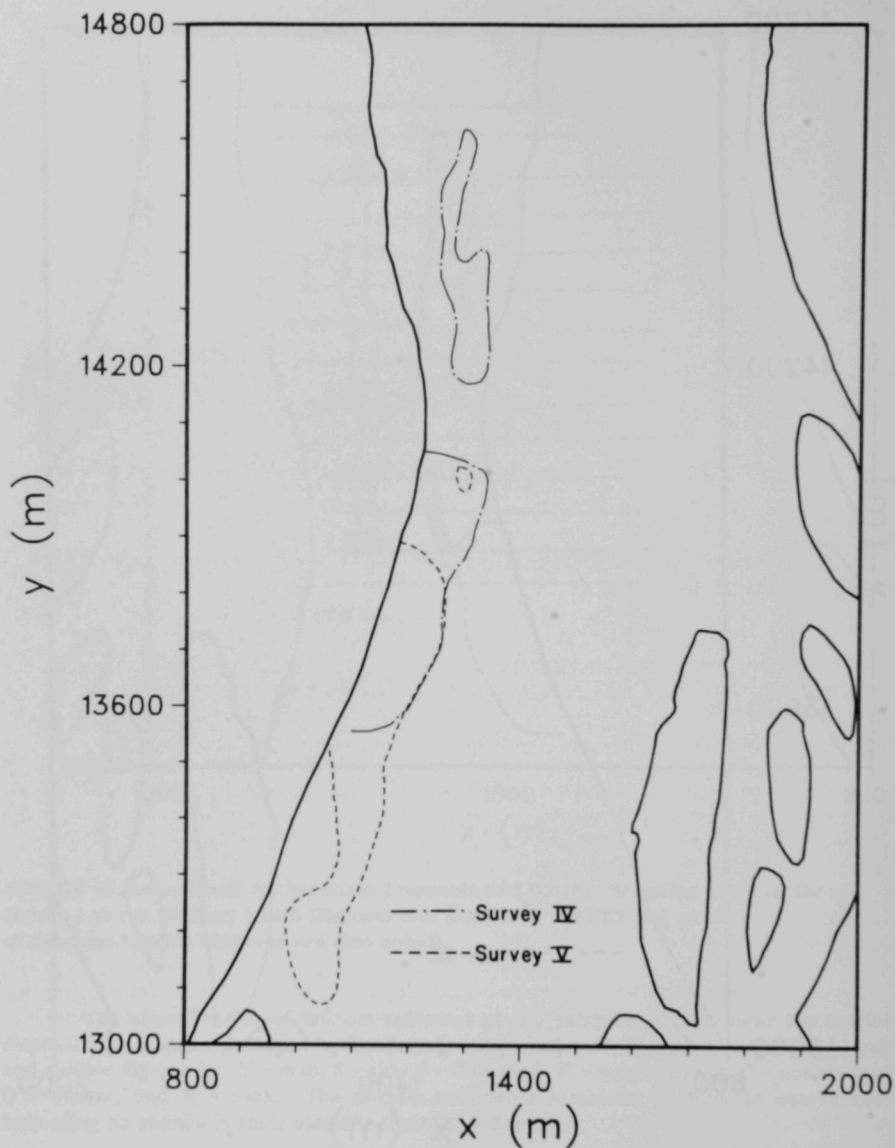
FIGURE 49 Distribution of Tagged Sand before and after the Spring 1983 Flood at the Whitney Island Disposal Site

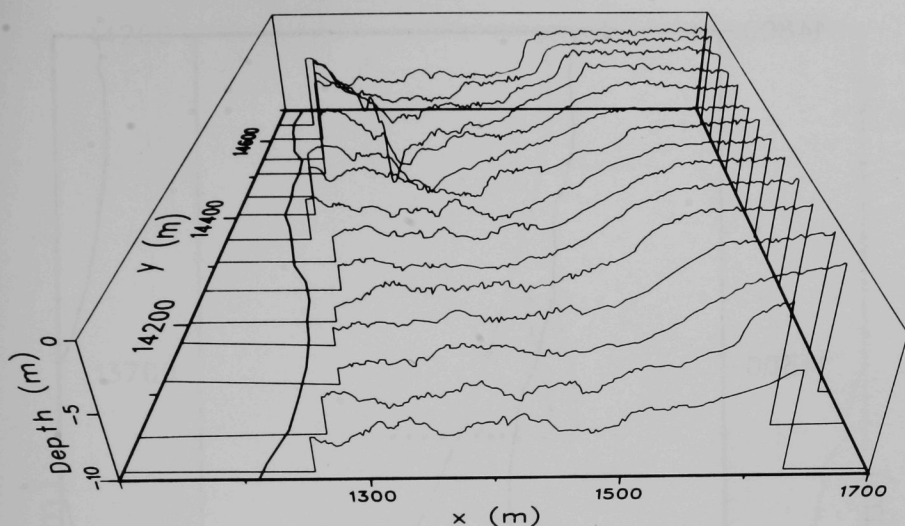
FIGURE 50 Perspective Plot of Transverse Bathymetric Transects for Survey VI at the Whitney Island Disposal Site

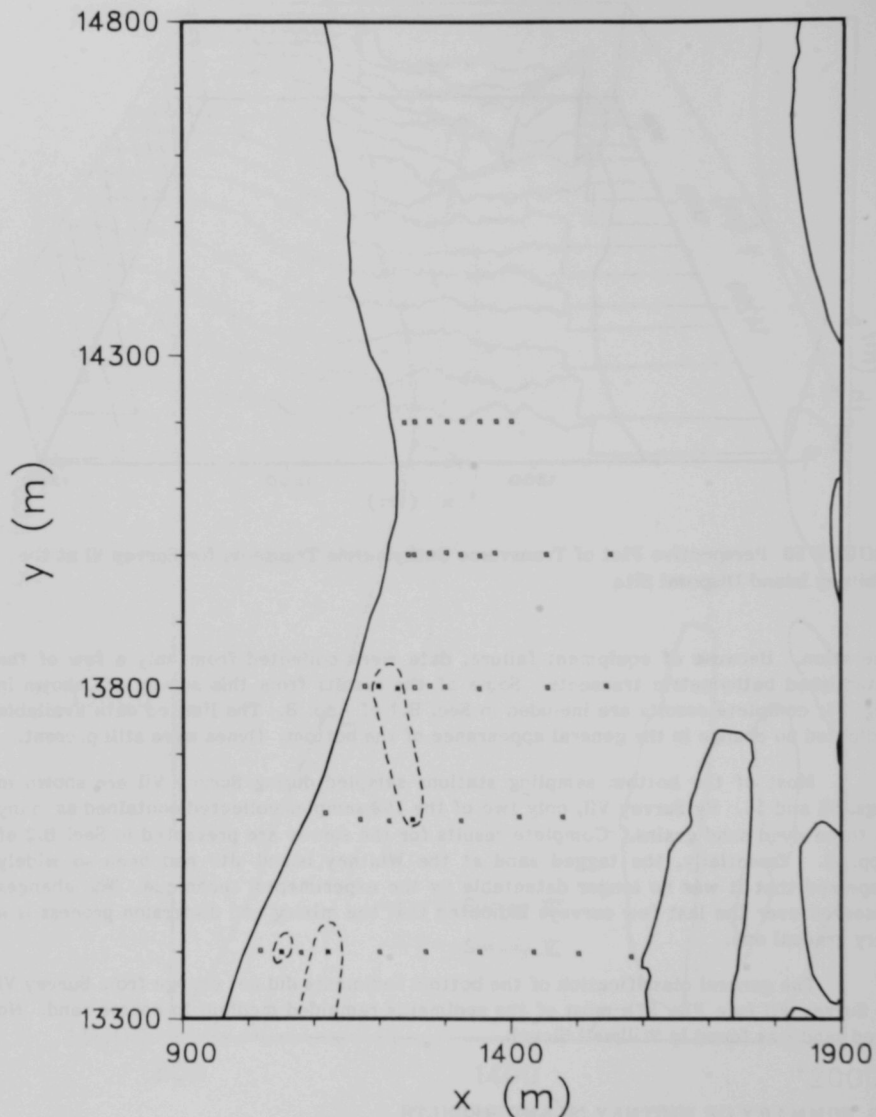
FIGURE 51 Sampling Locations for Survey VI at the Whitney Island Disposal Site
(solid symbols show locations where more than three dyed sand grains were observed)

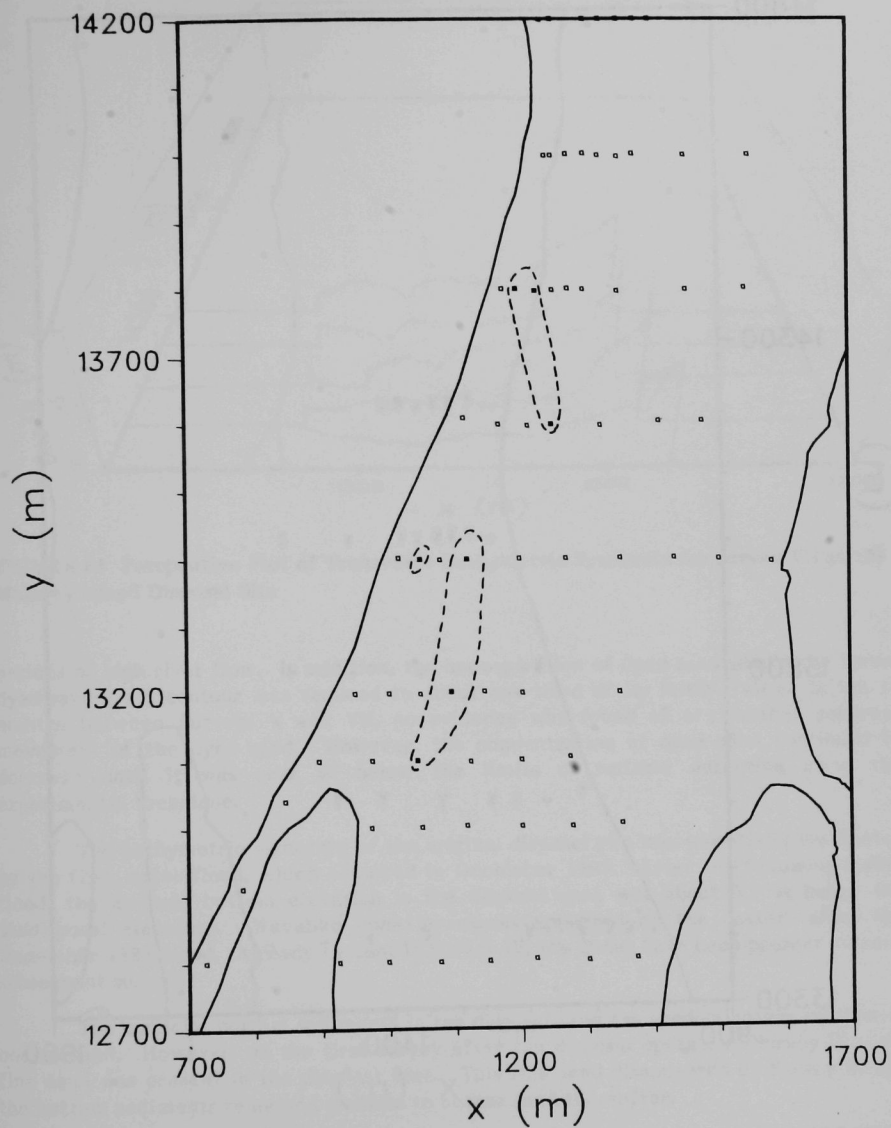
FIGURE 52 Sampling Locations for Survey VI Downstream of the Whitney Island Disposal Site (solid symbols show locations where more than three dyed sand grains were observed)

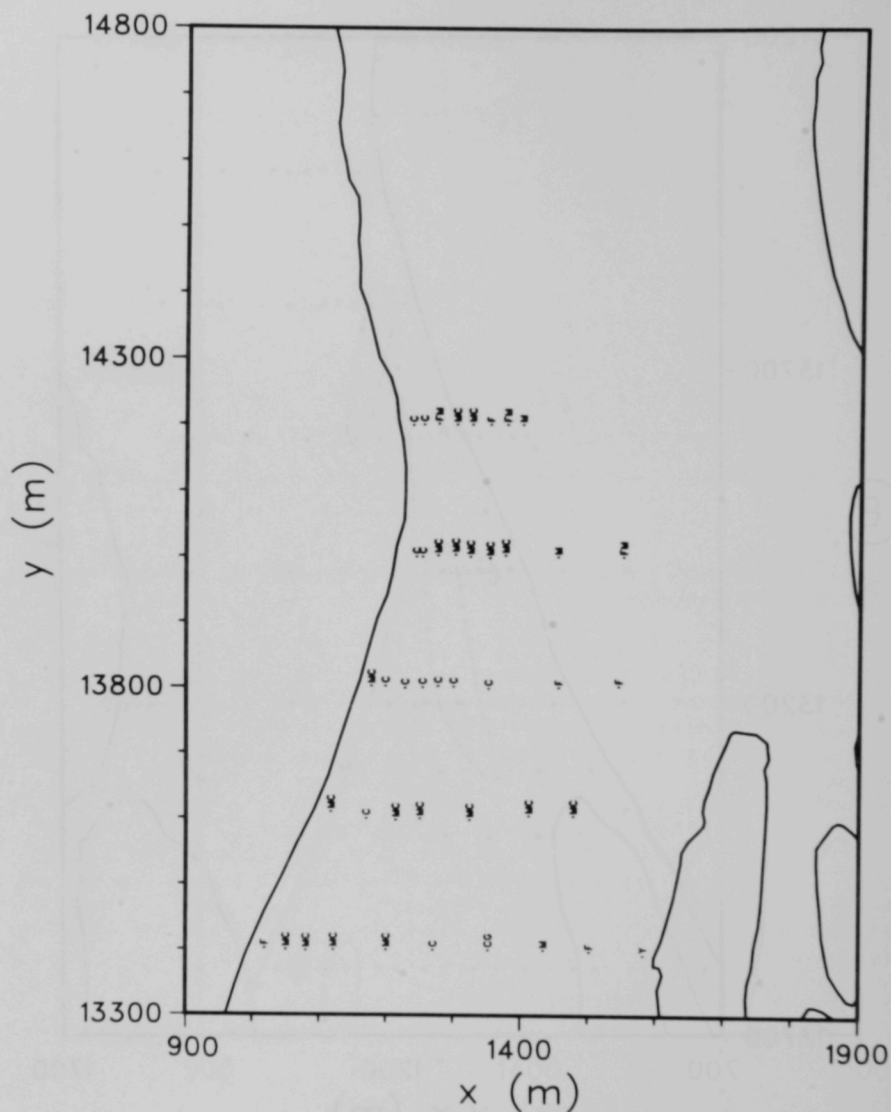
FIGURE 53 Approximate Classification of Bottom Sediments at Sampling Locations for Survey VI at the Whitney Island Disposal Site

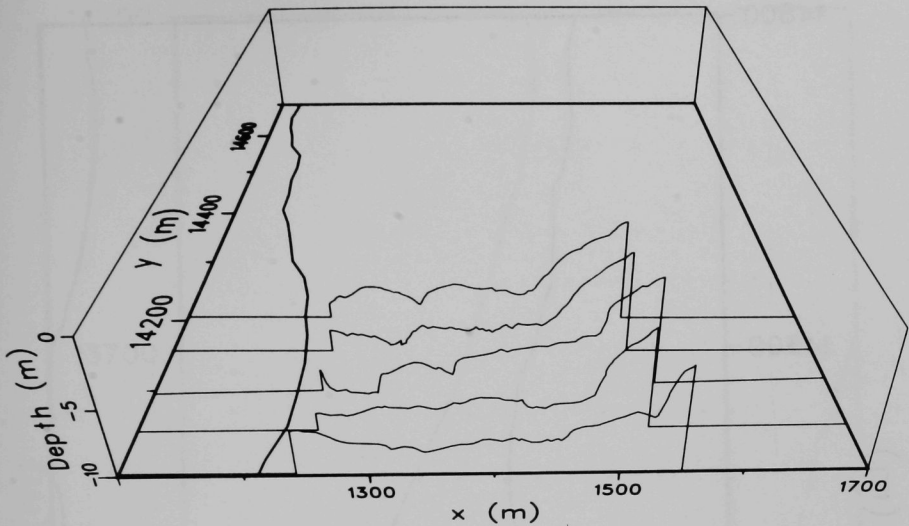
FIGURE 54 Perspective Plot of Transverse Bathymetric Transects for Survey VII at the Whitney Island Disposal Site

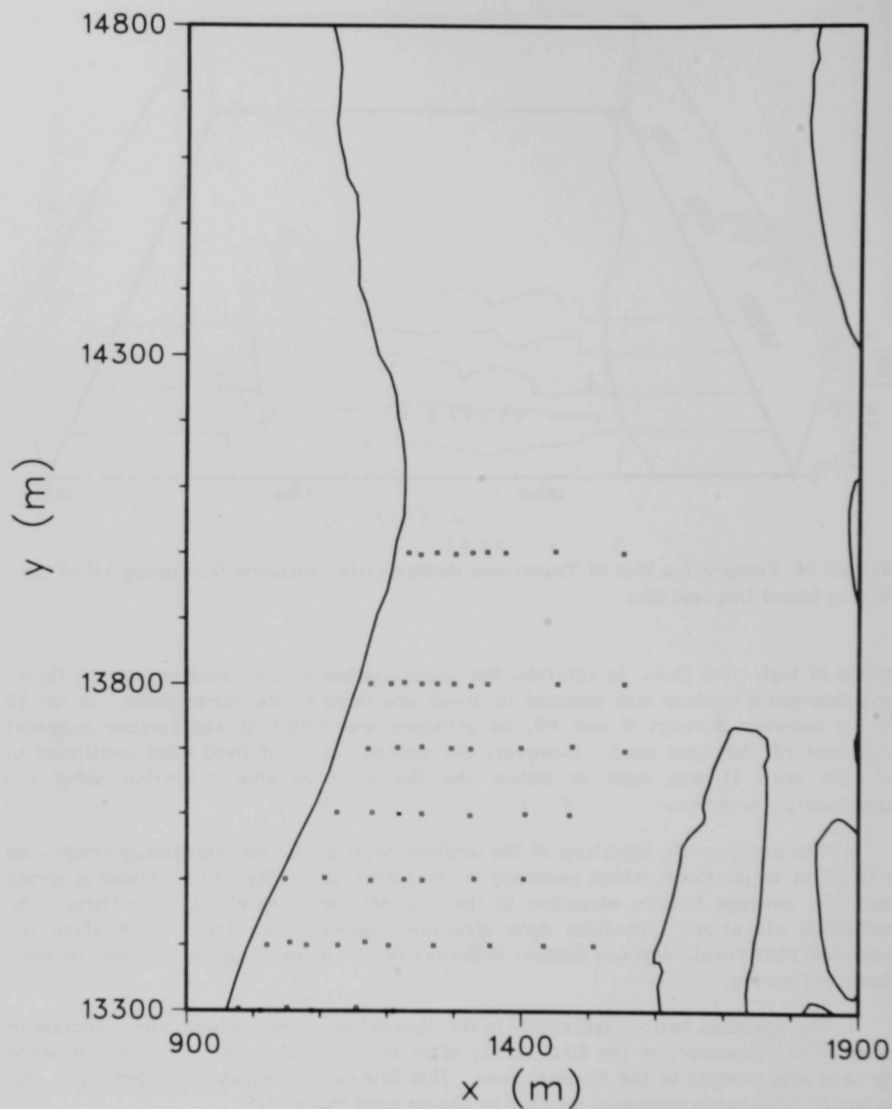
FIGURE 55 Sampling Locations for Survey VII at the Whitney Island Disposal Site (solid symbols show locations where more than three dyed sand grains were observed)

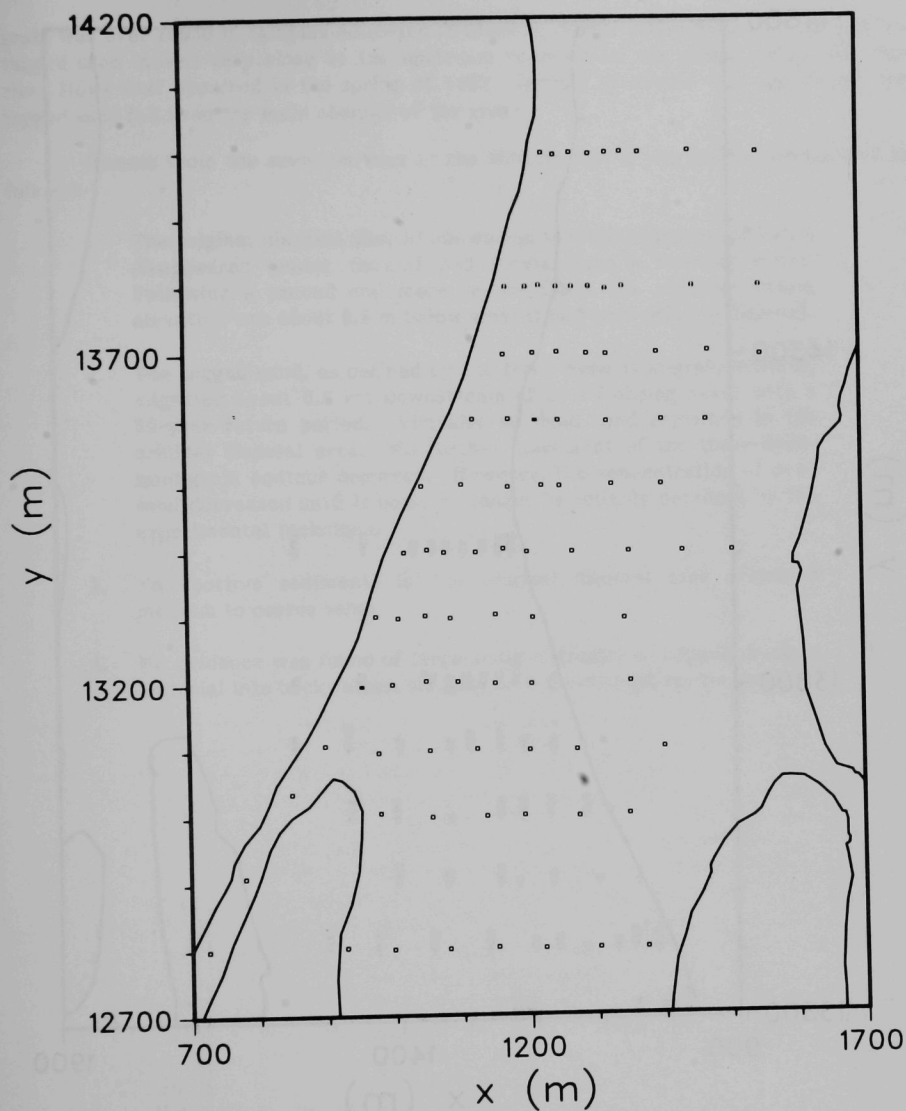
FIGURE 56 Sampling Locations for Survey VII Downstream of the Whitney Island Disposal Site (solid symbols show locations where more than three dyed sand grains were observed)

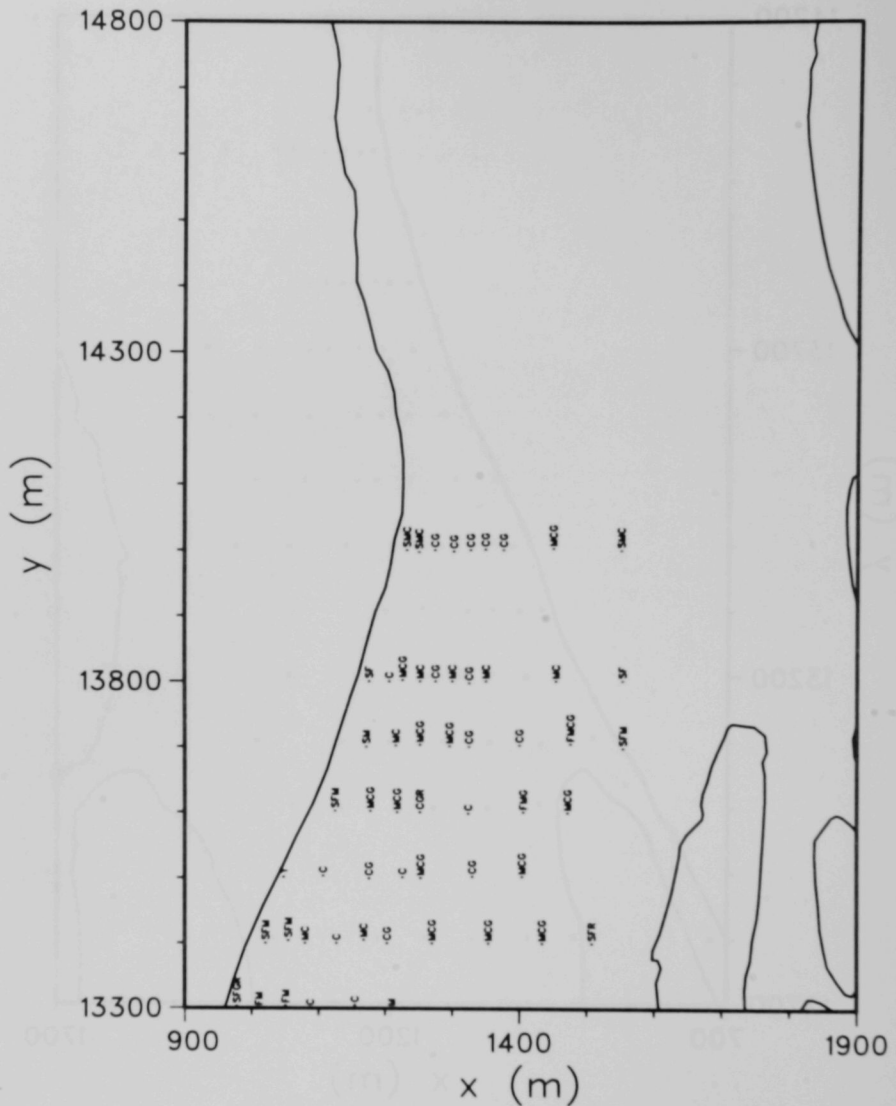
FIGURE 57 Approximate Classification of Bottom Sediments at Sampling Locations for Survey VII at the Whitney Island Disposal Site

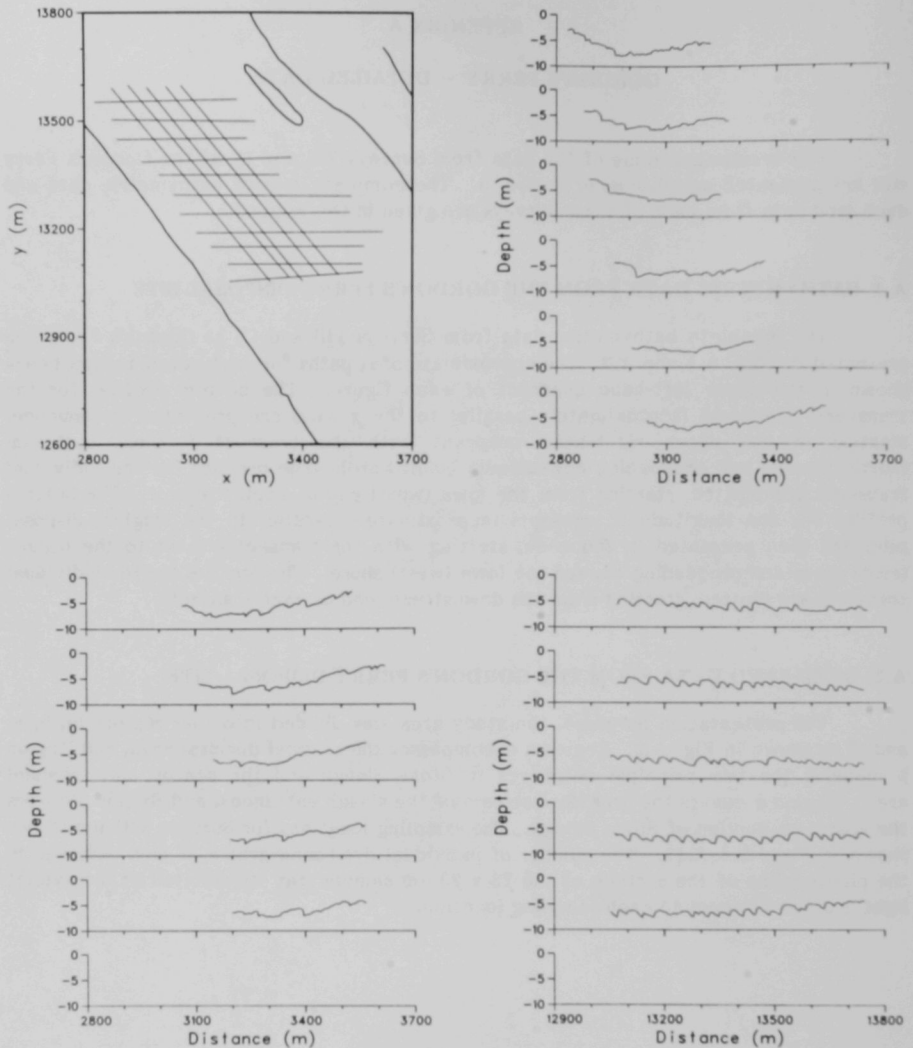
FIGURE A.1 Bathymetric Transects and Transverse and Longitudinal Bottom Profiles for Survey VIII at Gordon's Ferry on September 1, 1983

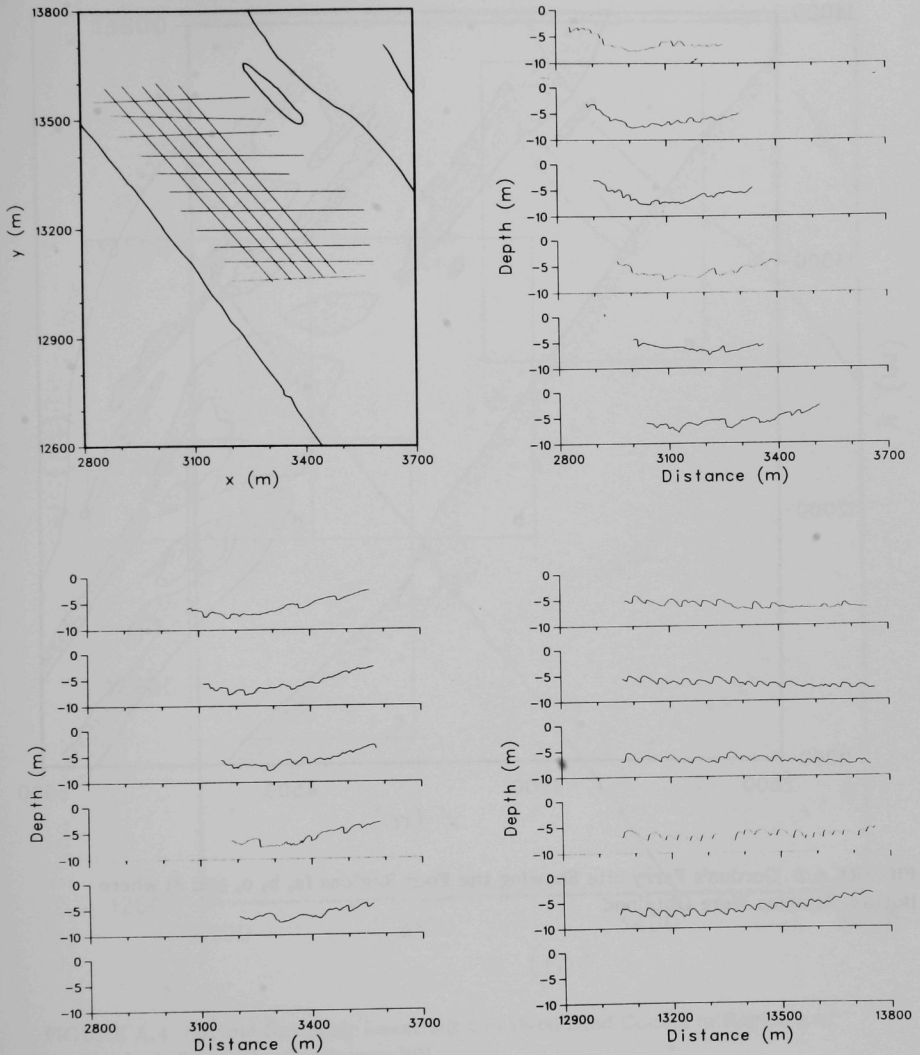
FIGURE A.2 Bathymetric Transects and Transverse and Longitudinal Bottom Profiles for Survey IX at Gordon's Ferry on September 20, 1984

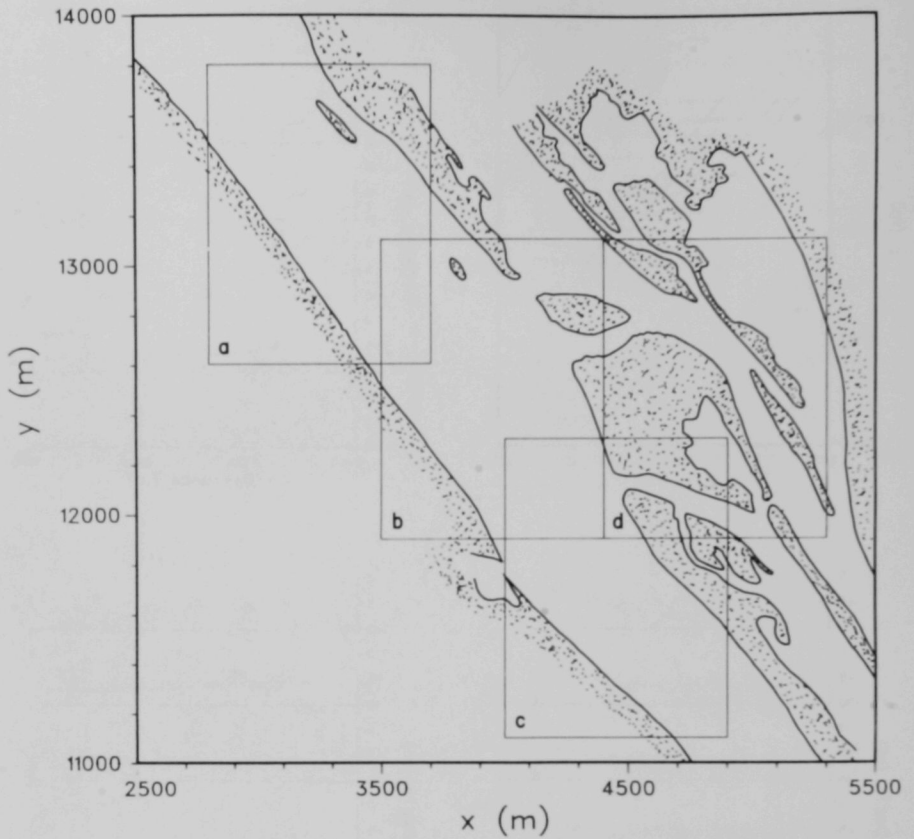
FIGURE A.3 Gordon's Ferry Site Showing the Four Regions (a, b, c, and d) where Bottom Samples Were Obtained

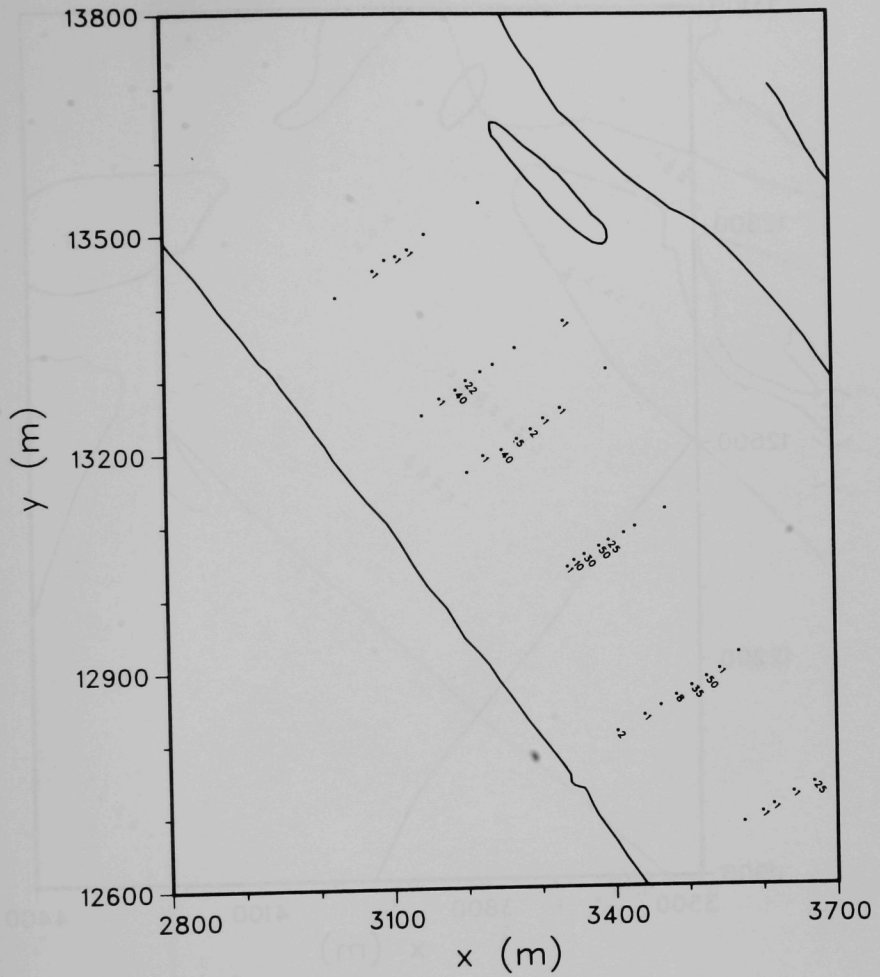
FIGURE A.4 Bottom Sampling Locations and Dyed Sand Counts in Region a of the Gordon's Ferry Site for Survey VIII

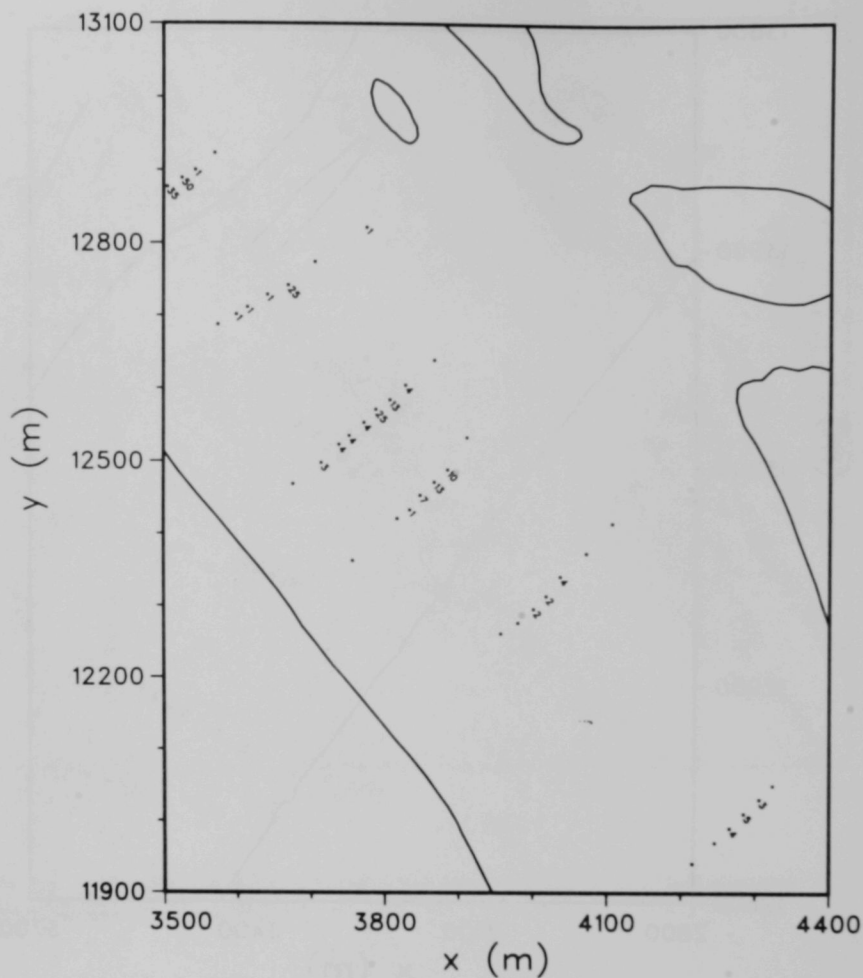
FIGURE A.5 Bottom Sampling Locations and Dyed Sand Counts in Region b of the Gordon's Ferry Site for Survey VIII

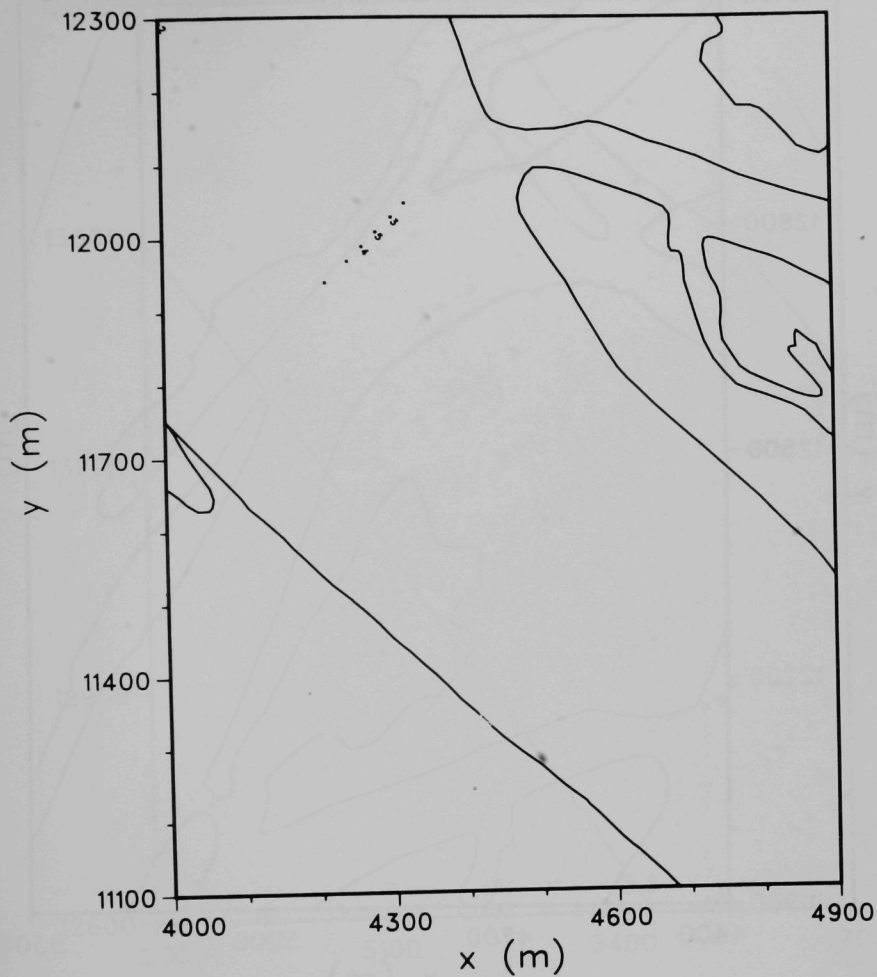
FIGURE A.6 Bottom Sampling Locations and Dyed Sand Counts in Region c of the Gordon's Ferry Site for Survey VIII

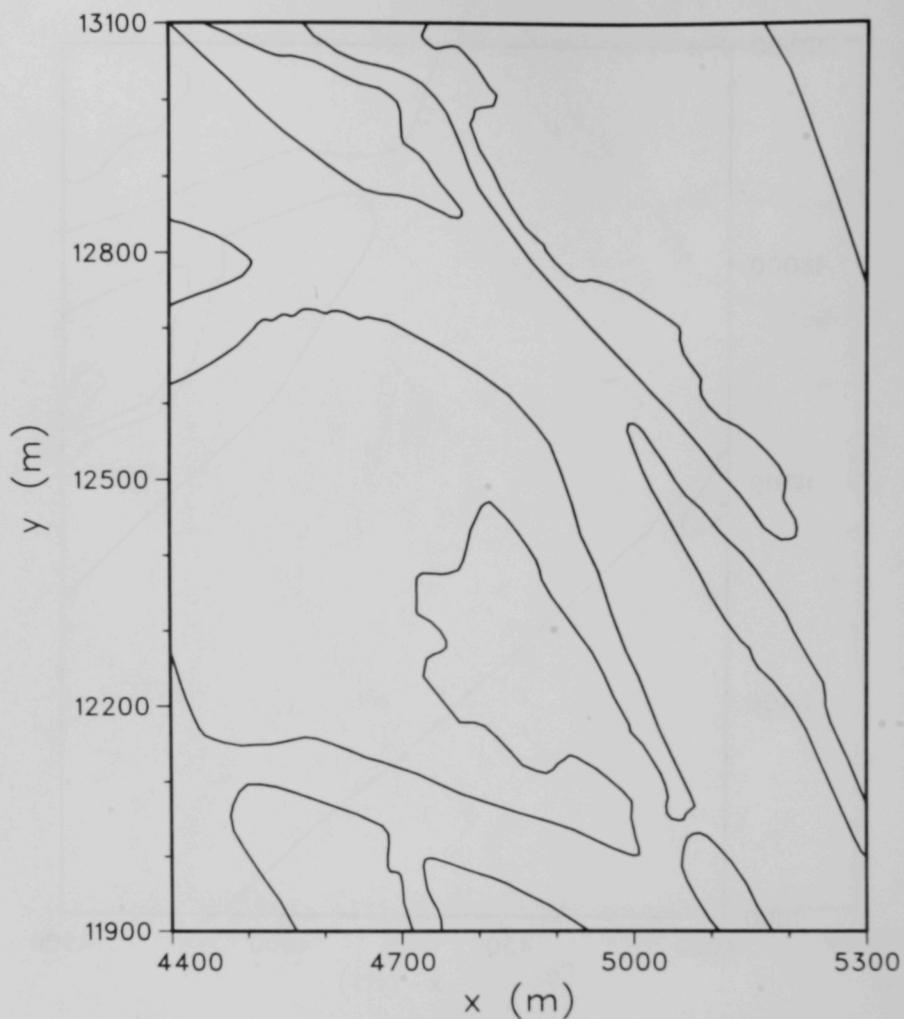
FIGURE A.7 Bottom Sampling Locations and Dyed Sand Counts in Region d of the Gordon's Ferry Site for Survey VIII

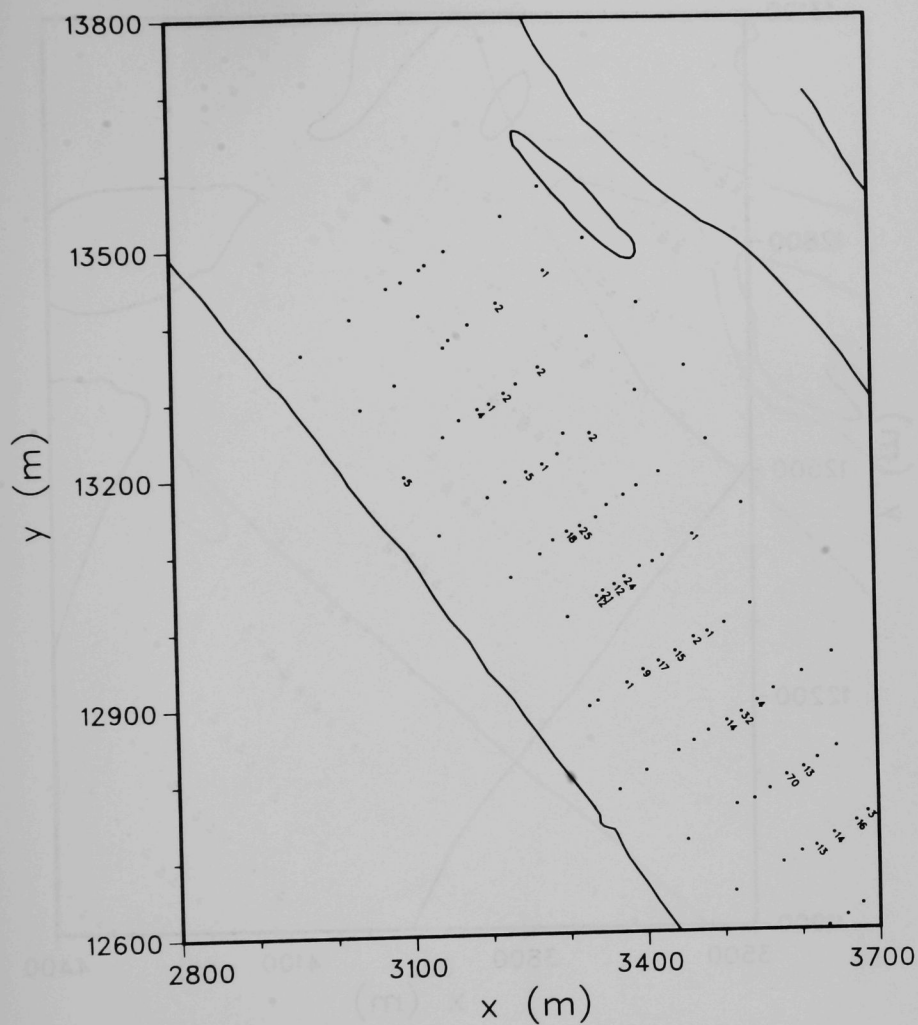
FIGURE A.8 Bottom Sampling Locations and Dyed Sand Counts in Region a of the Gordon's Ferry Site for Survey IX

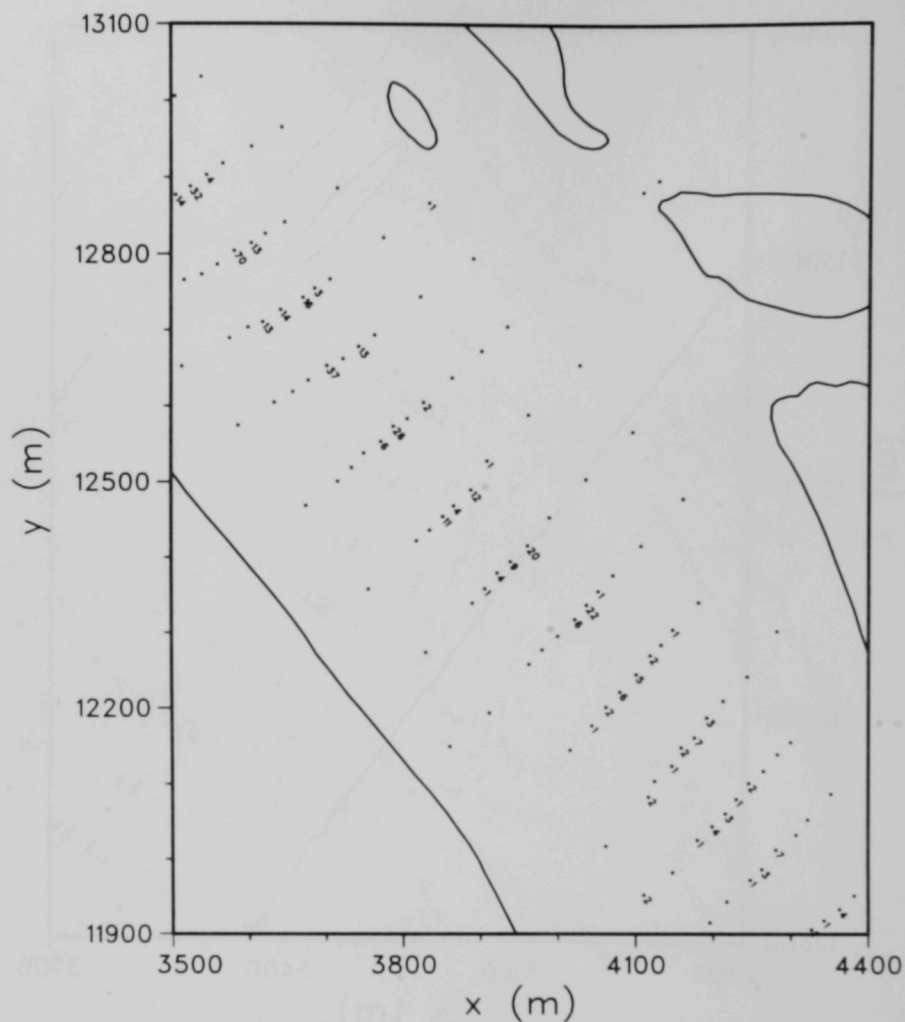
FIGURE A.9 Bottom Sampling Locations and Dyed Sand Counts in Region b of the Gordon's Ferry Site for Survey IX

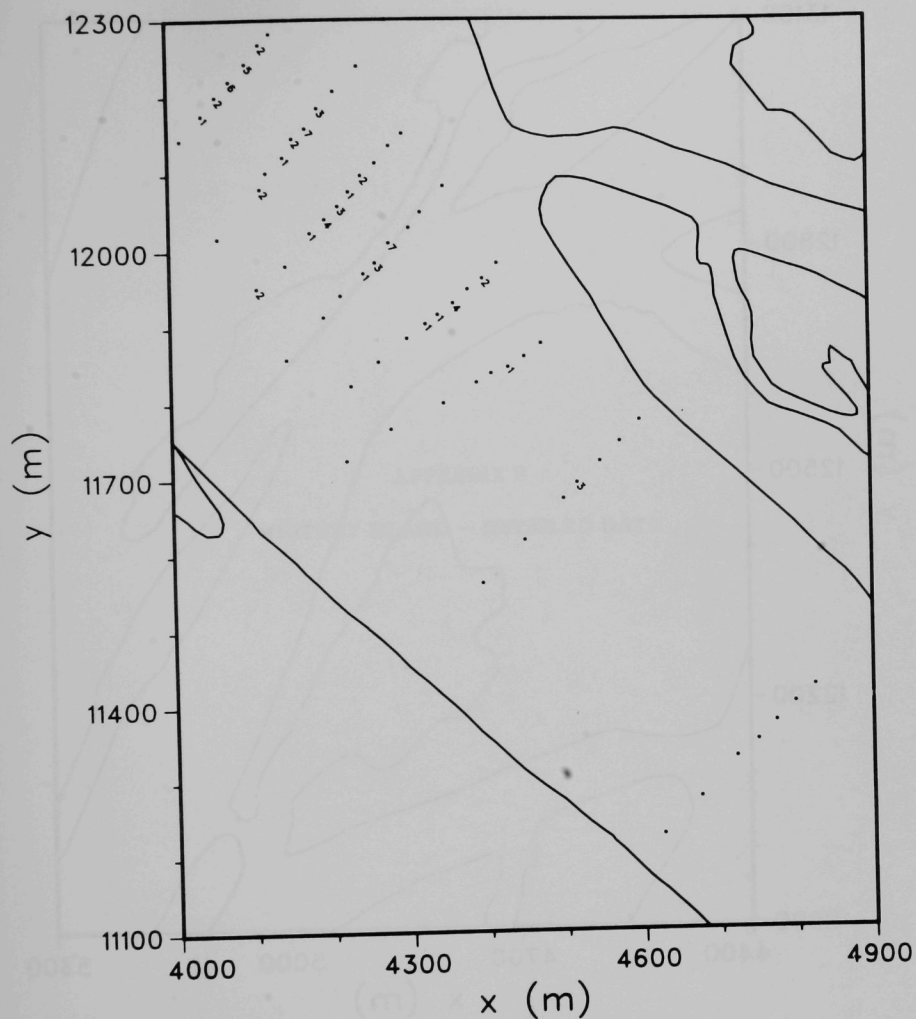
FIGURE A.10 Bottom Sampling Locations and Dyed Sand Counts in Region c of the Gordon's Ferry Site for Survey IX

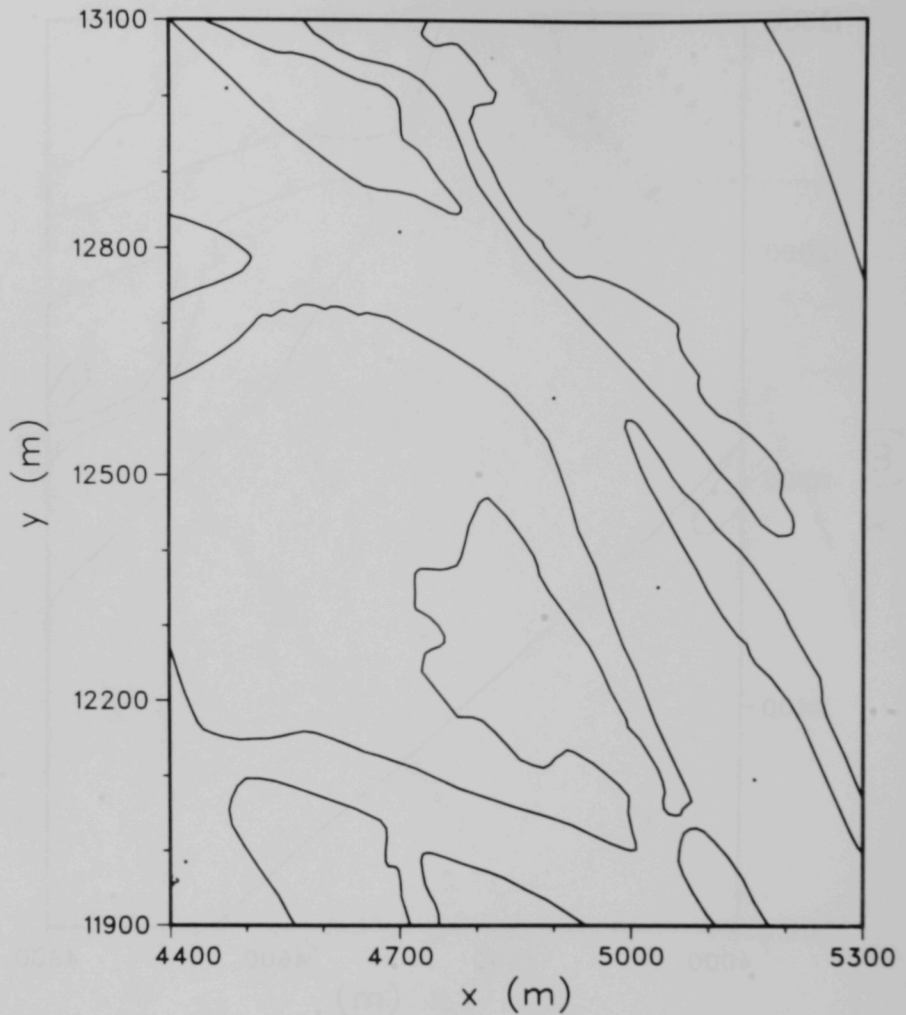
FIGURE A.11 Bottom Sampling Locations and Dyed Sand Counts in Region d of the Gordon's Ferry Site for Survey IX

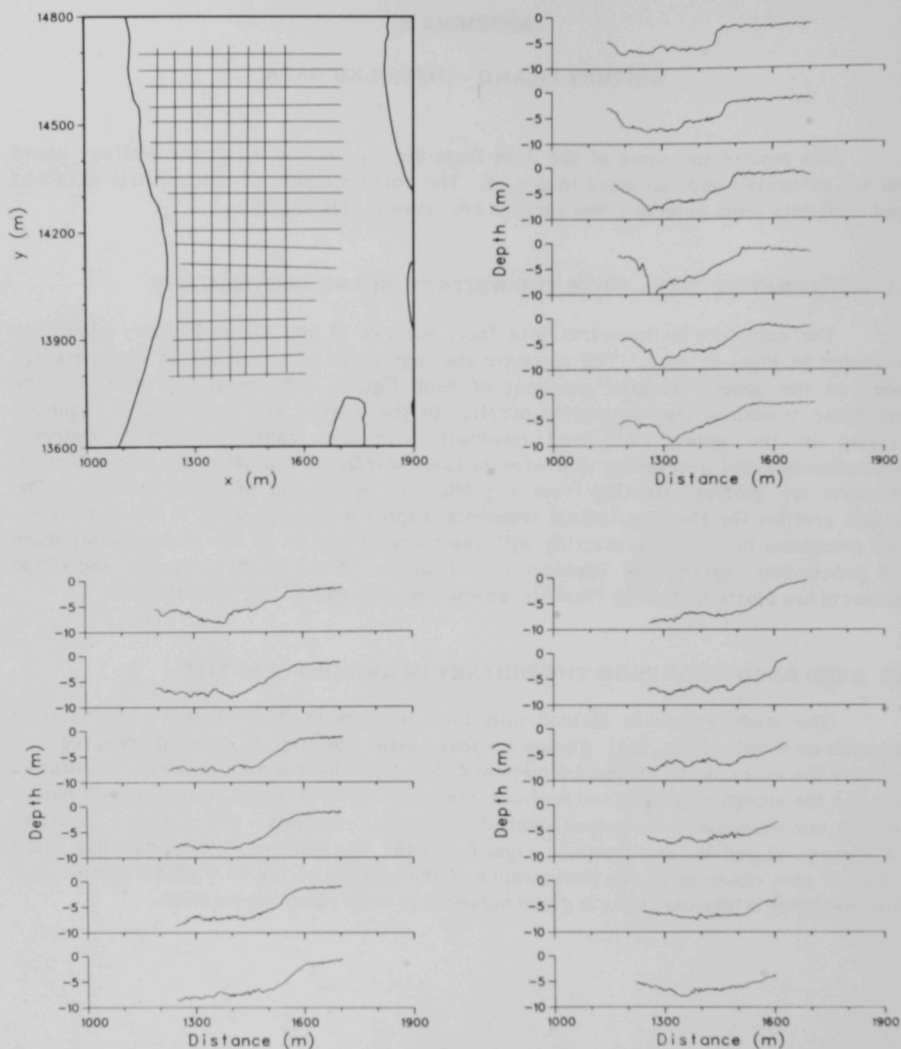
FIGURE B.1 Bathymetric Transects and Transverse Bottom Profiles for Survey VI at Whitney Island on November 30, 1983

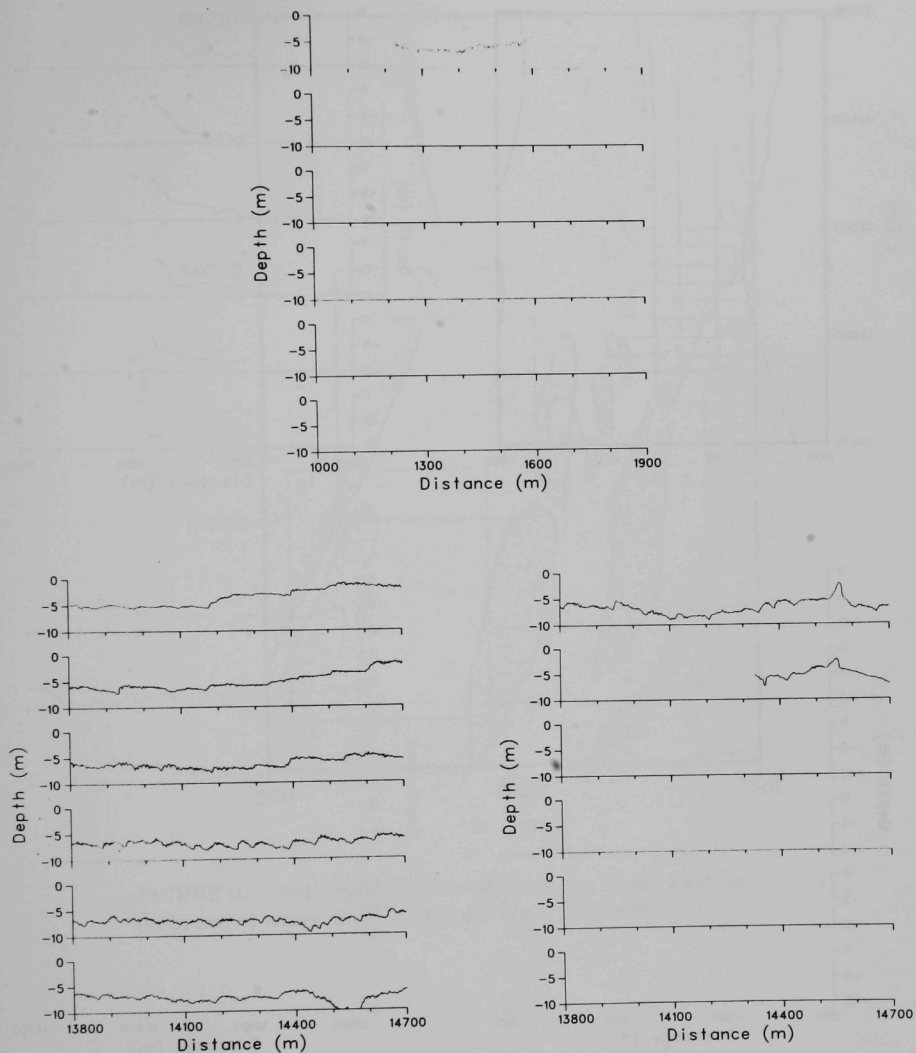
FIGURE B.2 Transverse and Longitudinal Bottom Profiles for Survey VI at Whitney Island on November 30, 1983

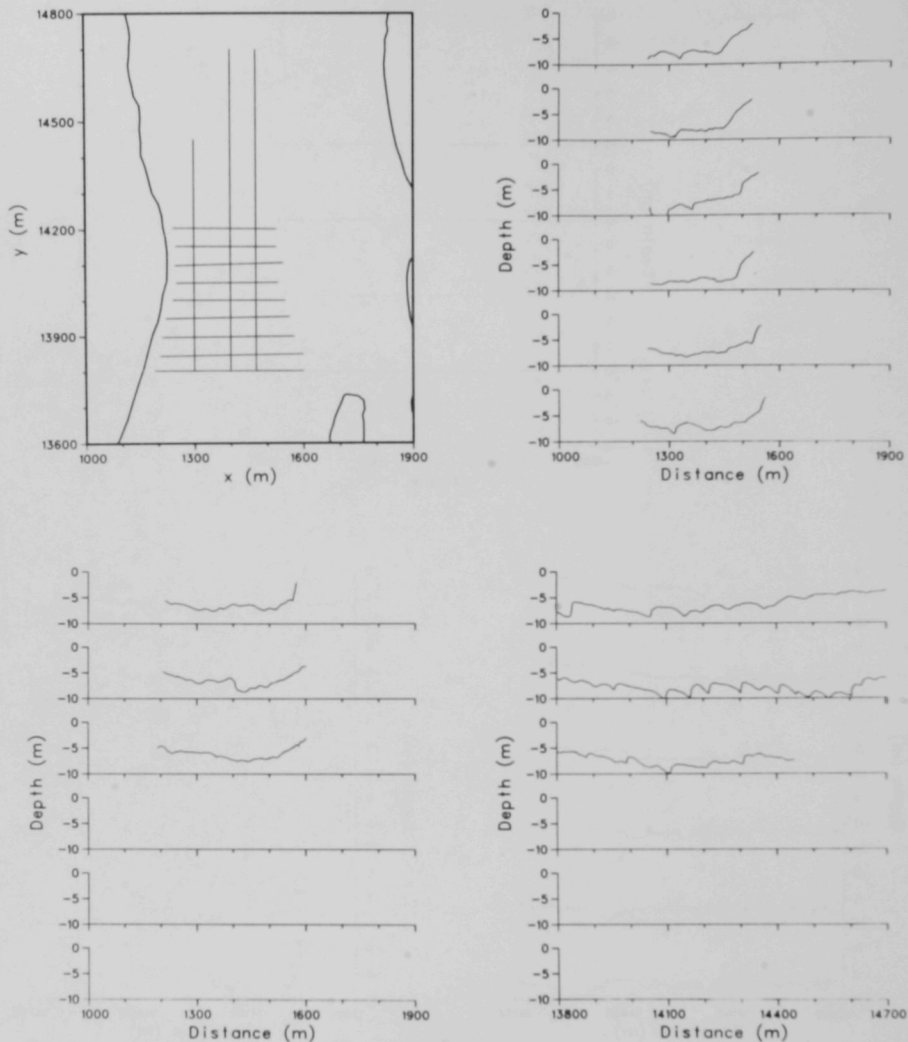
FIGURE B.3 Bathymetric Transects and Transverse and Longitudinal Bottom Profiles for Survey VII at Whitney Island on October 3, 1984

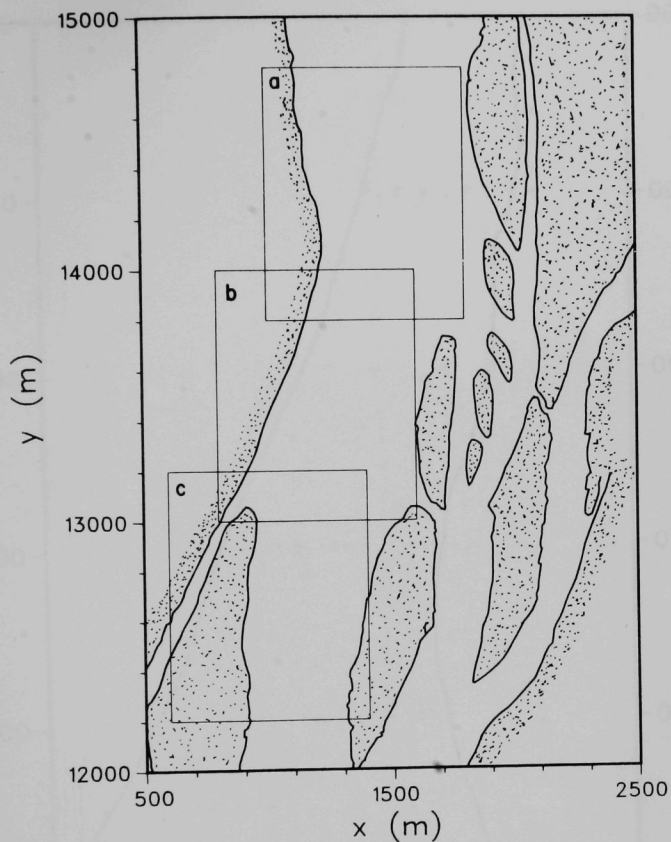
FIGURE B.4 Whitney Island Site Showing the Three Regions (a, b, and c) where Bottom Samples Were Obtained
